Figure 8: Study Reach Photographs

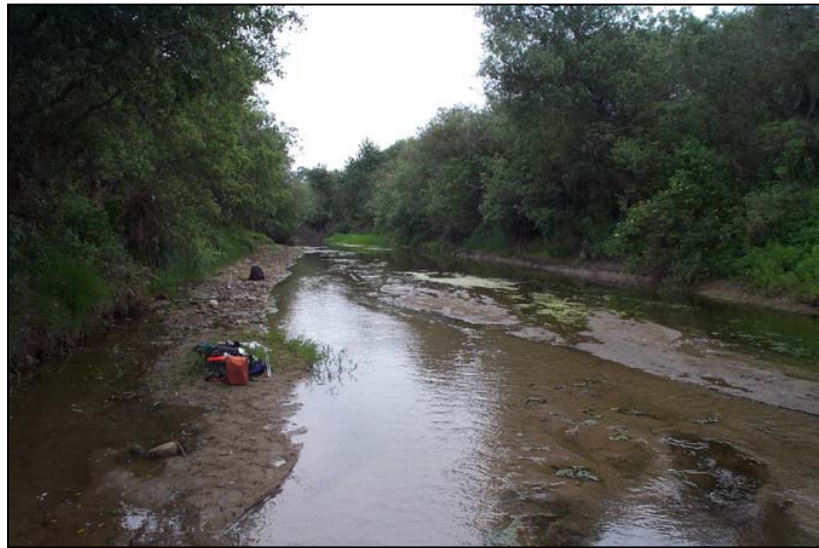
The above photograph was taken at Atascadero Creek near Goleta Slough (Reach AT-1). This creek has been heavily affected by human development. Routine flood control maintenance activities include grading (i.e., discing) the creekbed and removing vegetation and woody debris. The result is an exposed, wide, fairly homogenous creekbed with little diversity in terms of vegetation, substrata and microhabitat (e.g., riffles, pools, snags, etc.). Pollution inputs degrade water quality, as evidenced by high conductivity. Many aquatic organisms are unable to tolerate these conditions, thus species diversity at this study reach is low.

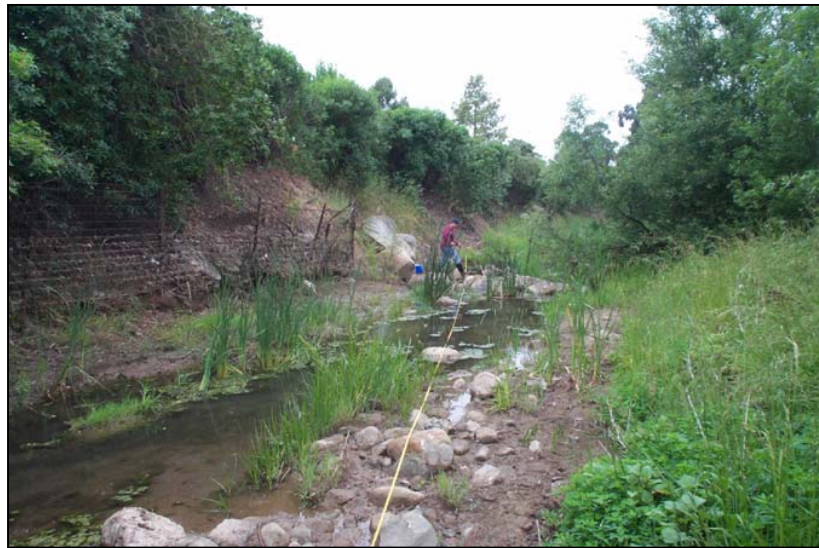
This photograph was taken at Atascadero Creek just downstream of the confluence with Cienaguitas Creek (Reach AT-2). This creek reach has been heavily affected by human development. In the past, the creek banks and bed at this reach were graded, and largely stripped of native riparian vegetation. Riprap and revetment were placed on the banks in an effort to stabilize them. Non-native vegetation dominates the plant community. Similar to AT-1, the aquatic community has low diversity and is dominated by pollution-tolerant species.
