Figure 9: Study Reach Photographs

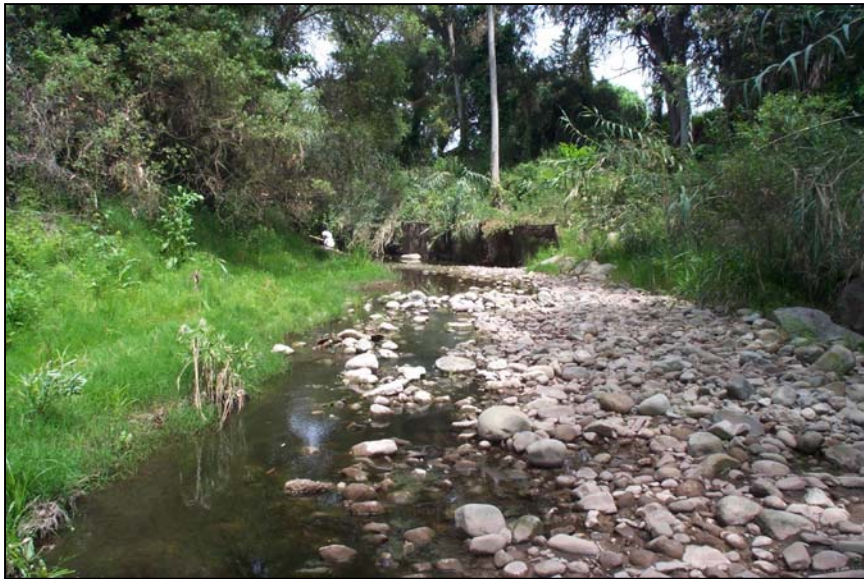
The above photograph was taken at Carpinteria Creek downstream of Carpinteria Avenue (Reach C-1). This creek has been heavily degraded by alterations to the creekbed and banks, clearing of native riparian and wetland vegetation and invasion by non-native vegetation such as giant reed, eucalyptus, English ivy and grasses. Pollution inputs from upstream agricultural and urban areas have degraded water quality, as evidenced by elevated conductivity and nutrient concentrations. Aquatic species diversity at this study reach is low.

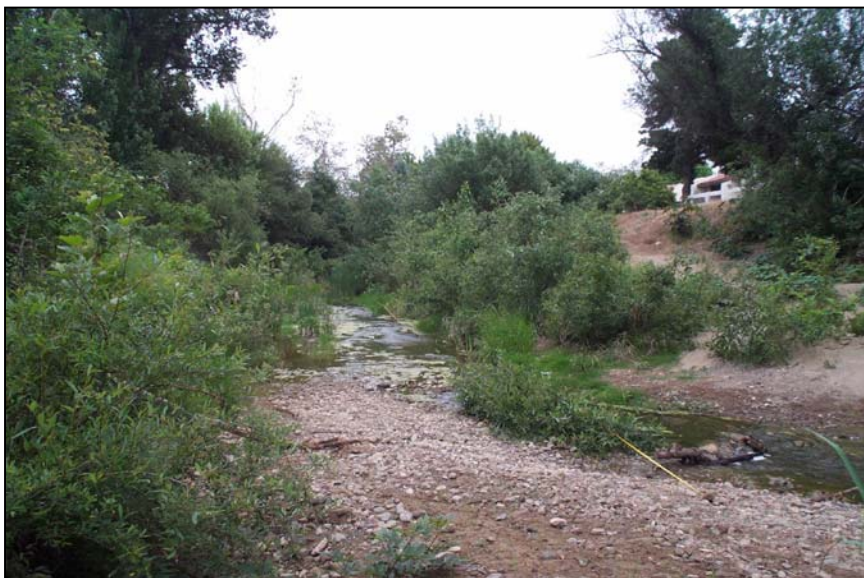
The above photograph was taken at San Jose Creek between Hollister Avenue and U.S. 101 (Reach SJ-1). Similar to C-1, this creek reach has been degraded by alterations to the creekbed and banks, loss of native vegetation, invasion by non-native plants, and water pollution, as evidenced by elevated conductivity and nutrient concentrations. Extensive mats of floating algae are present in the stream. It may be that algae growth in this reach is enhanced by excess nutrients (i.e., eutrophication) and exposure of the creek bottom to direct sunlight.
