## FIGURE 8: COMPARISON OF LOW GRADIENT STUDY REACHES GAV-1 VS. AB-1 AND M-1

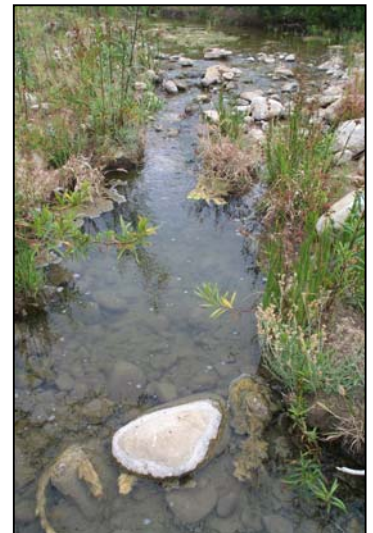
Gaviota Creek (GAV-1)

Due to high coastal development intensity, there are few examples of fairly intact coastal lowland streams on the South Coast. Lower Gaviota Creek is one of the best remaining examples, despite some upstream impacts from roads (U.S. 101) and cattle grazing (i.e., note herbaceous lands in watershed map, top left). Lower Gaviota Creek meanders through a natural alluvial flood plain and has a fairly intact, mostly native riparian corridor (see top right photo). The stream bed alternates between riffles (mostly fast and shallow) and small to medium-sized pools. Substrate is composed mostly of small boulders, cobble, and gravel (see photograph to the right). The aquatic community at GAV-1 is relatively diverse, including many sensitive species such as southwestern pond turtle and several families of caddisflies and mayflies.
