FIGURE 9: DISTURBED STREAMS

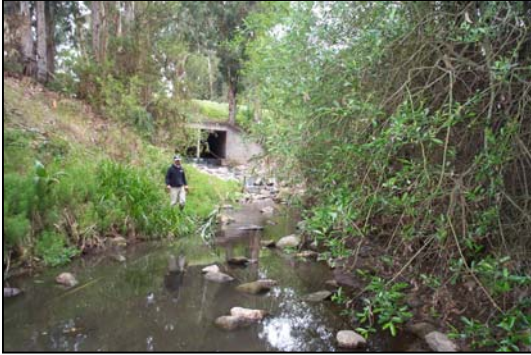
Arroyo Burro (AB-2)

These photographs show examples of highly degraded streams in urbanized areas. These streams are affected by a variety of anthropogenic stressors including encroaching development, road crossings, culverts, channel straightening, bank stabilization structures, routine channel maintenance for flood control purposes, altered hydrology (i.e., impervious surfaces, surface and ground water withdrawals), increased fine sediment inputs, polluted runoff from developed areas, loss of riparian vegetation, and the establishment of non-native plant species such as giant reed, eucalyptus, German ivy, periwinkle, and a variety of others. The aquatic communities of these streams are greatly diminished in terms of species diversity and sensitive species composition.

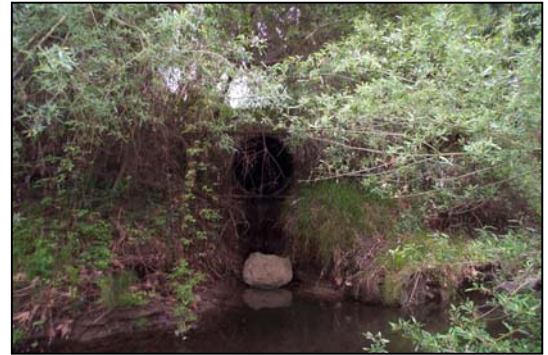
Storm drain inlet to Arroyo Burro (AB-2)
