APPENDIX B

Storm and Precipitation Tracking

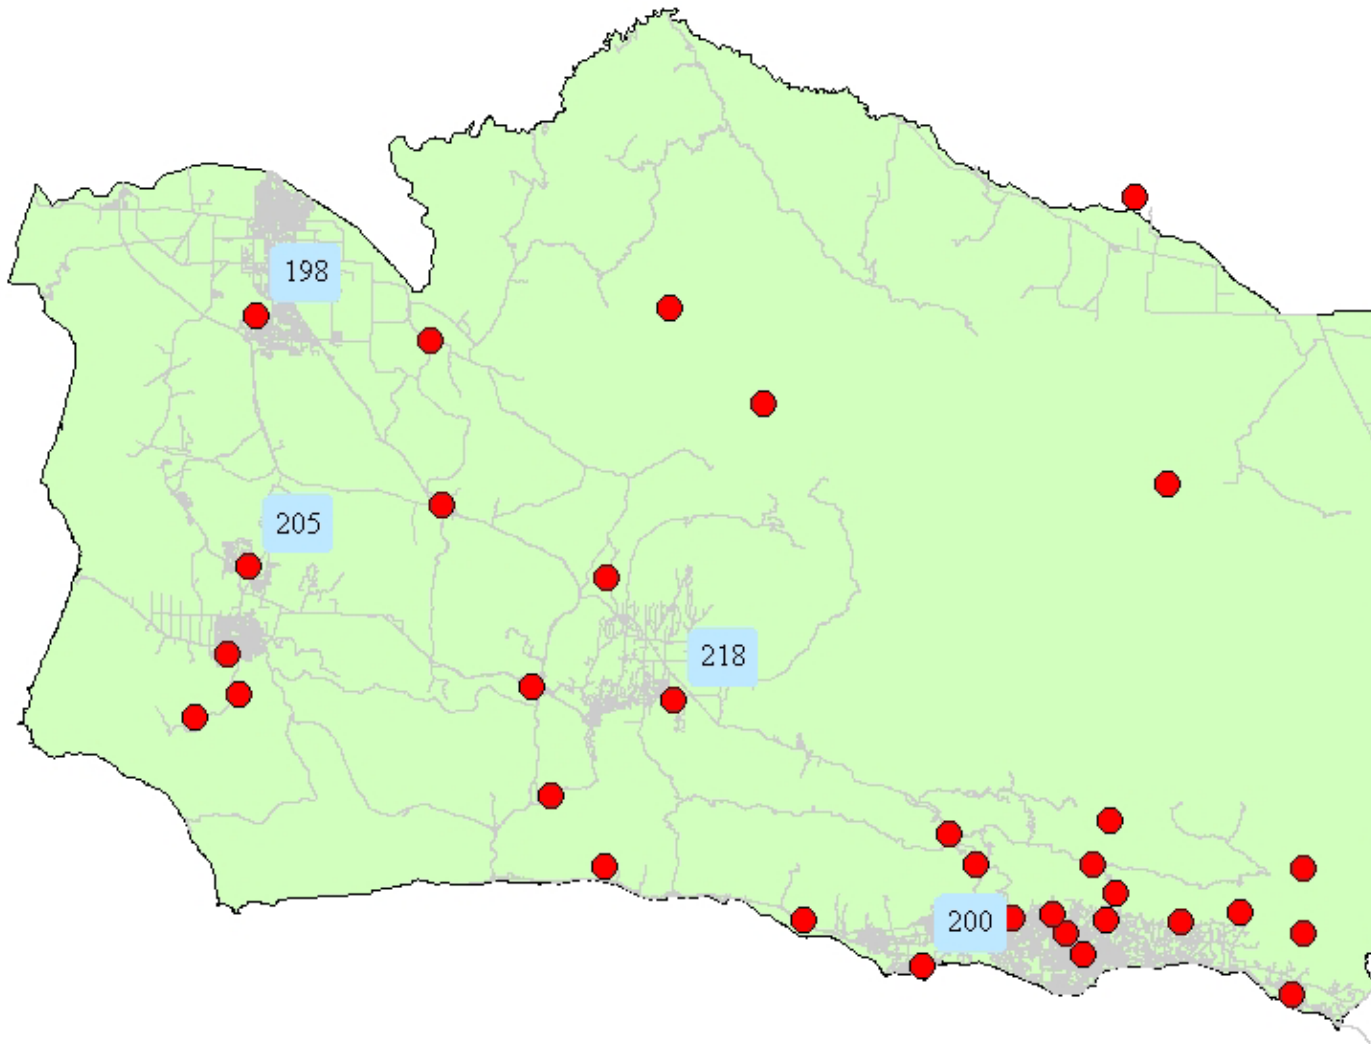
Figure B-1. Rain Gauges in Santa Barbara County

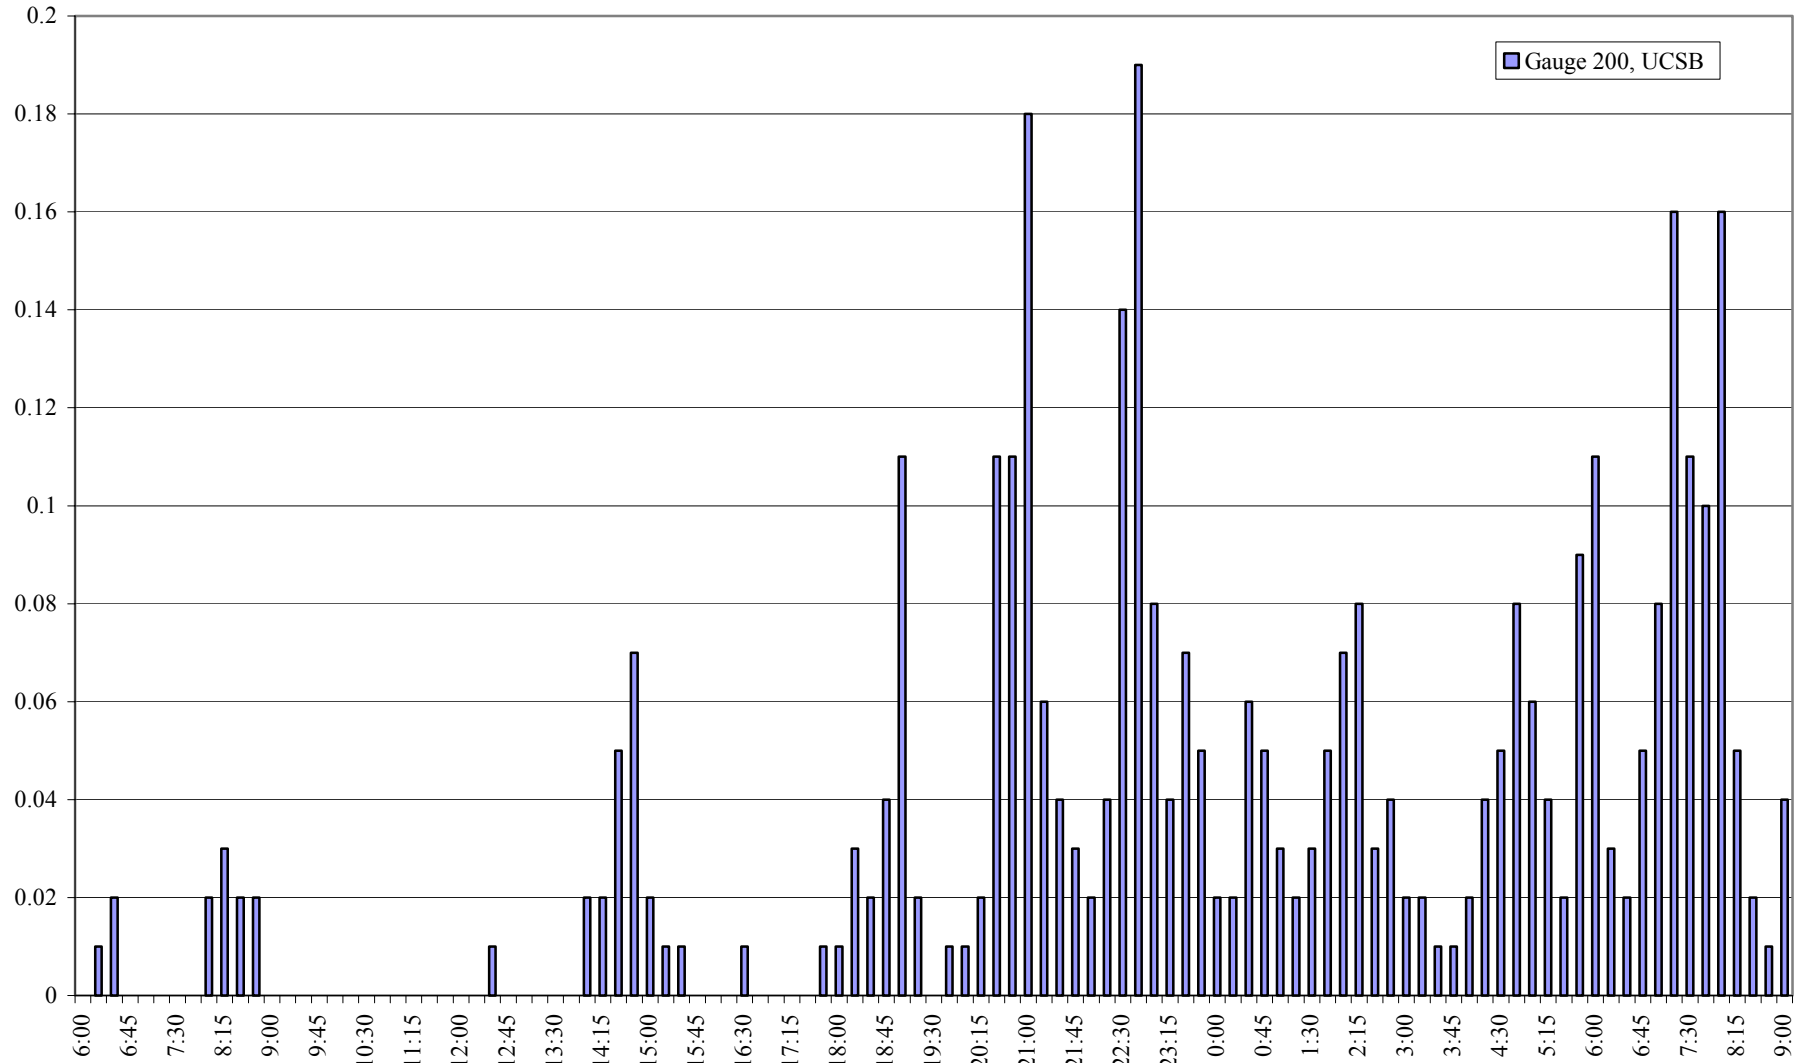
Figure B-2a. Rainfall for November 7-8, in inches (San Jose creek sampled 1450-0829)

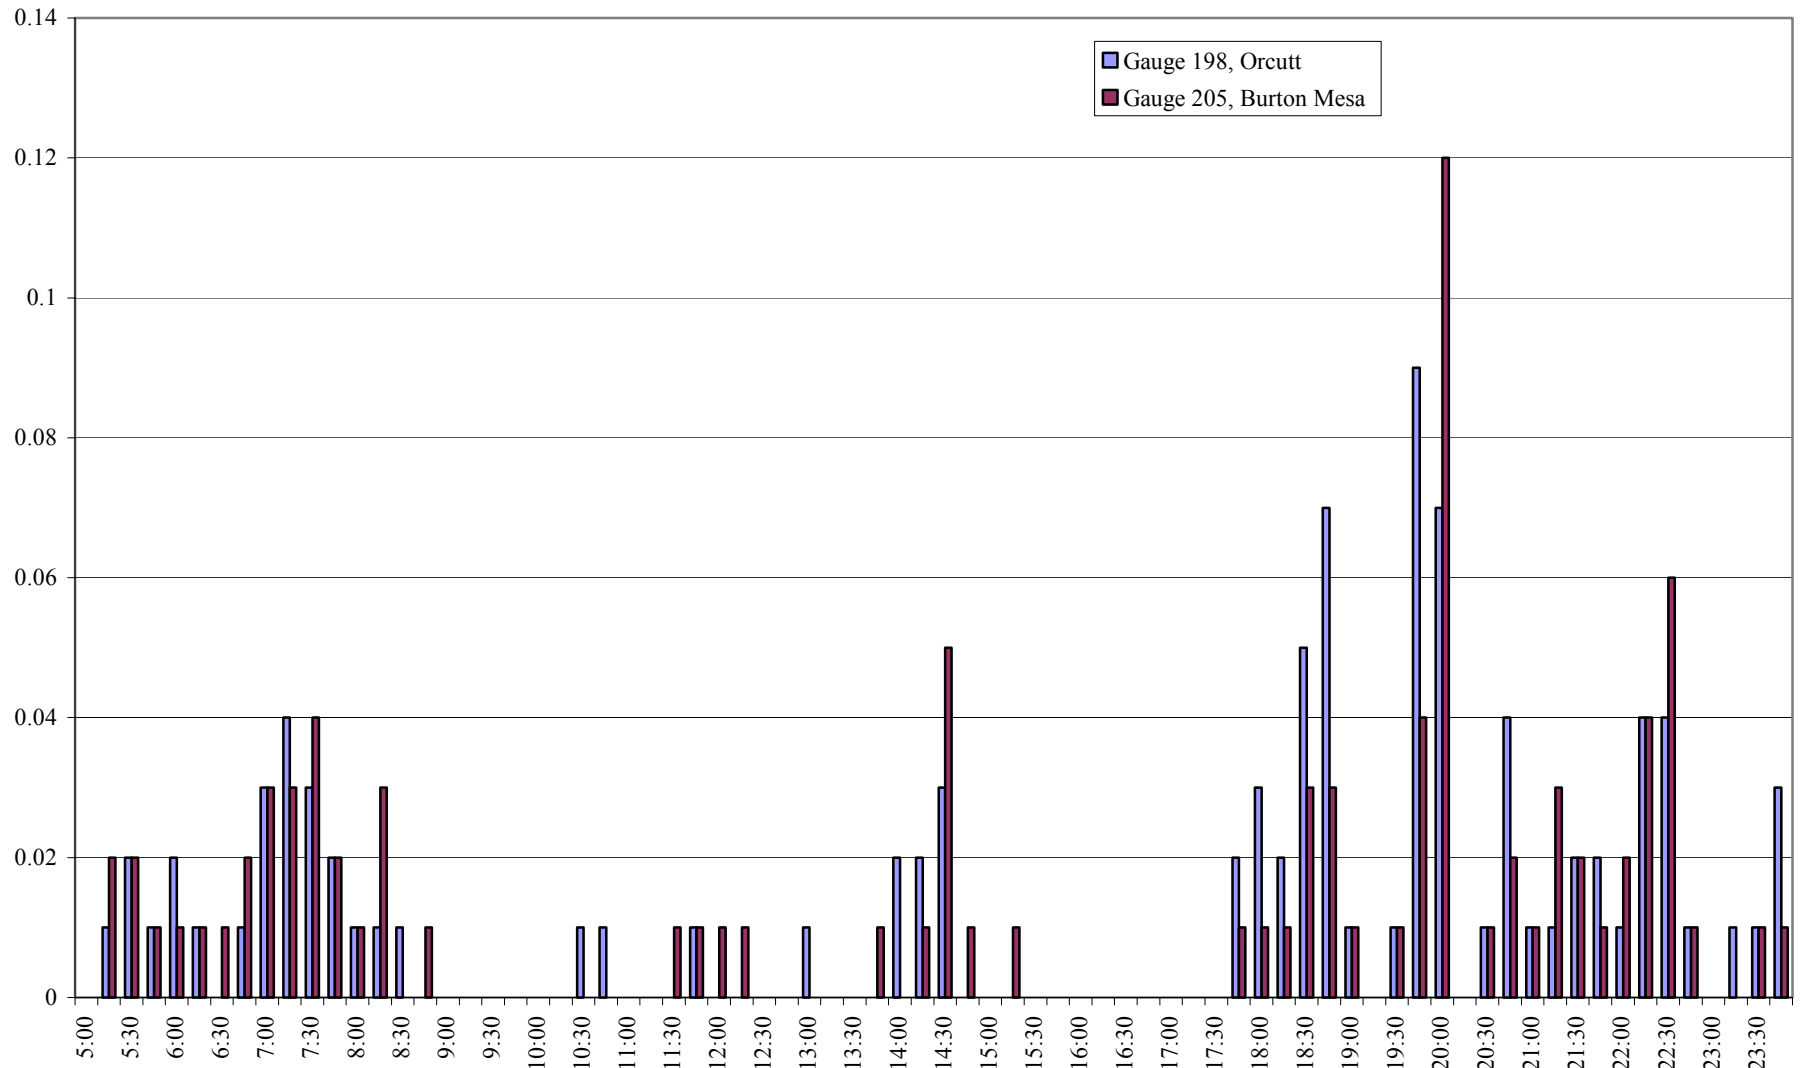
Figure B-2b. Rainfall for November 7-8, in inches (North County creeks sampled 0950 to 2200)

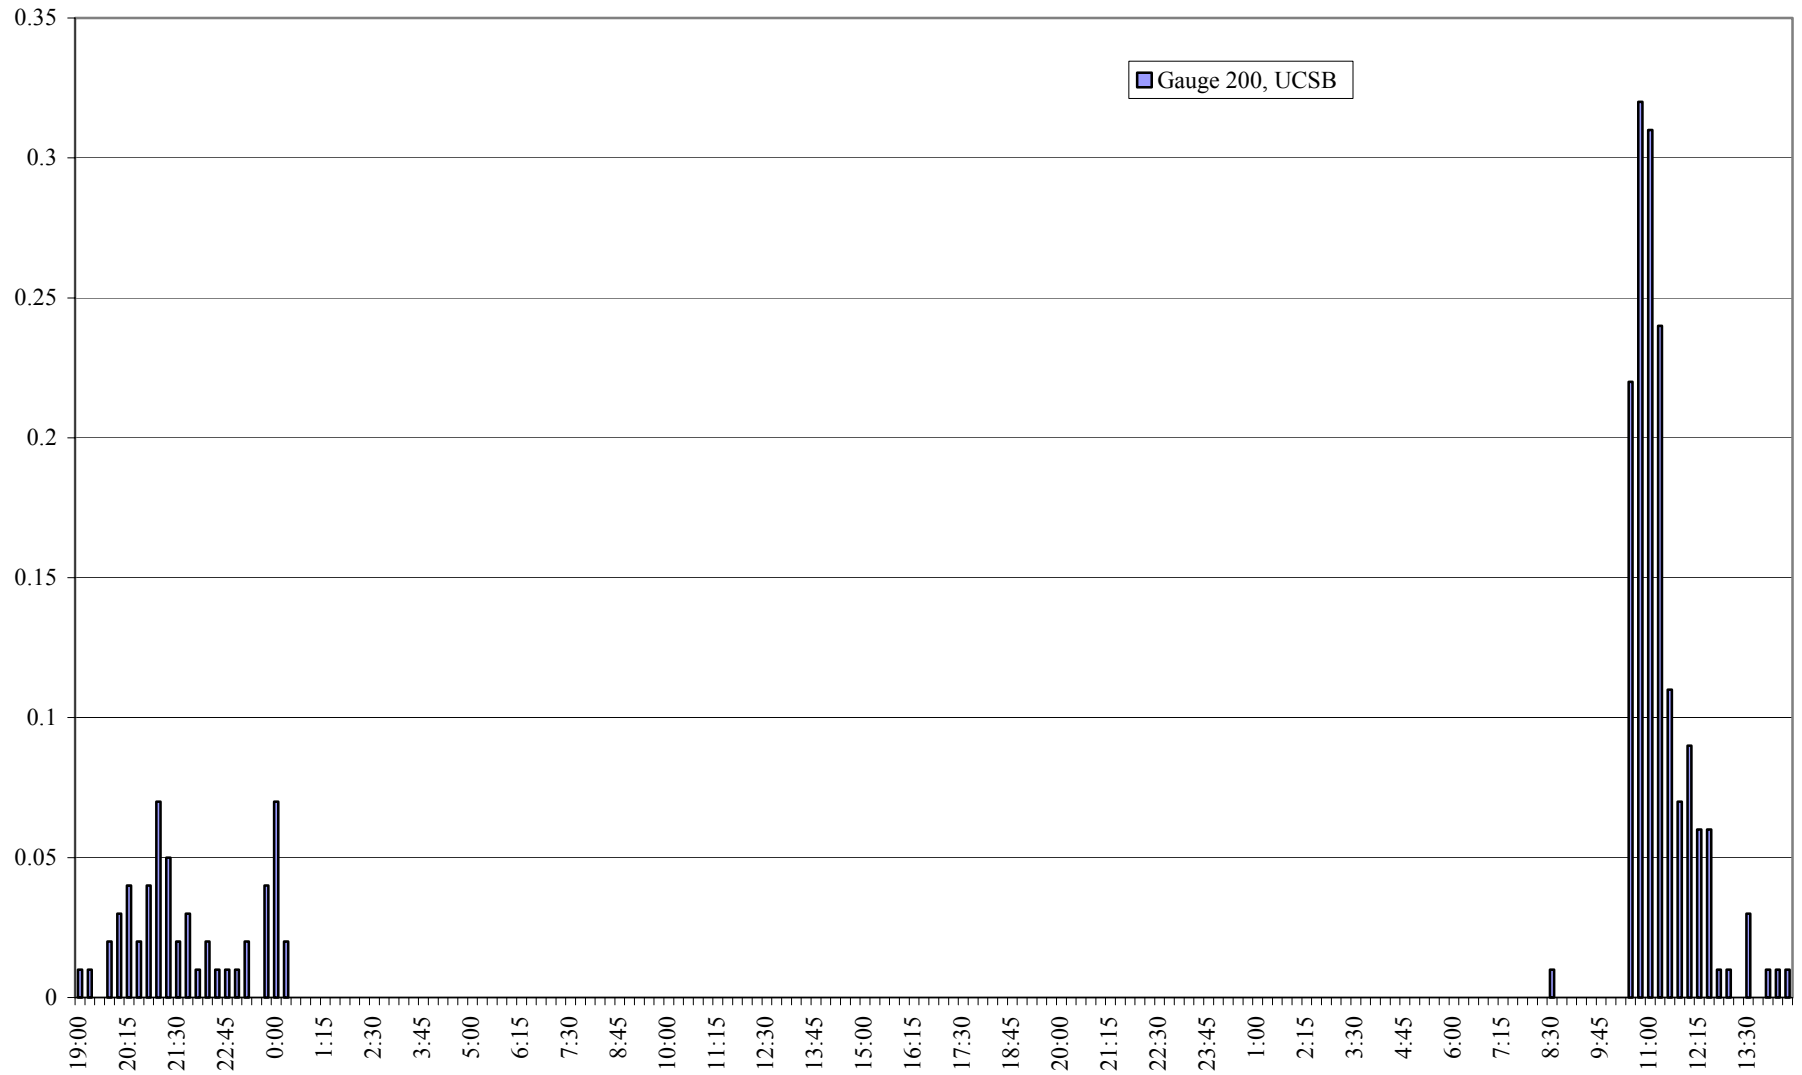
Figure B-3a. Rainfall for December 14-16, in inches (San Jose creek sampled 2150 [12/14]-1550 [12/16])

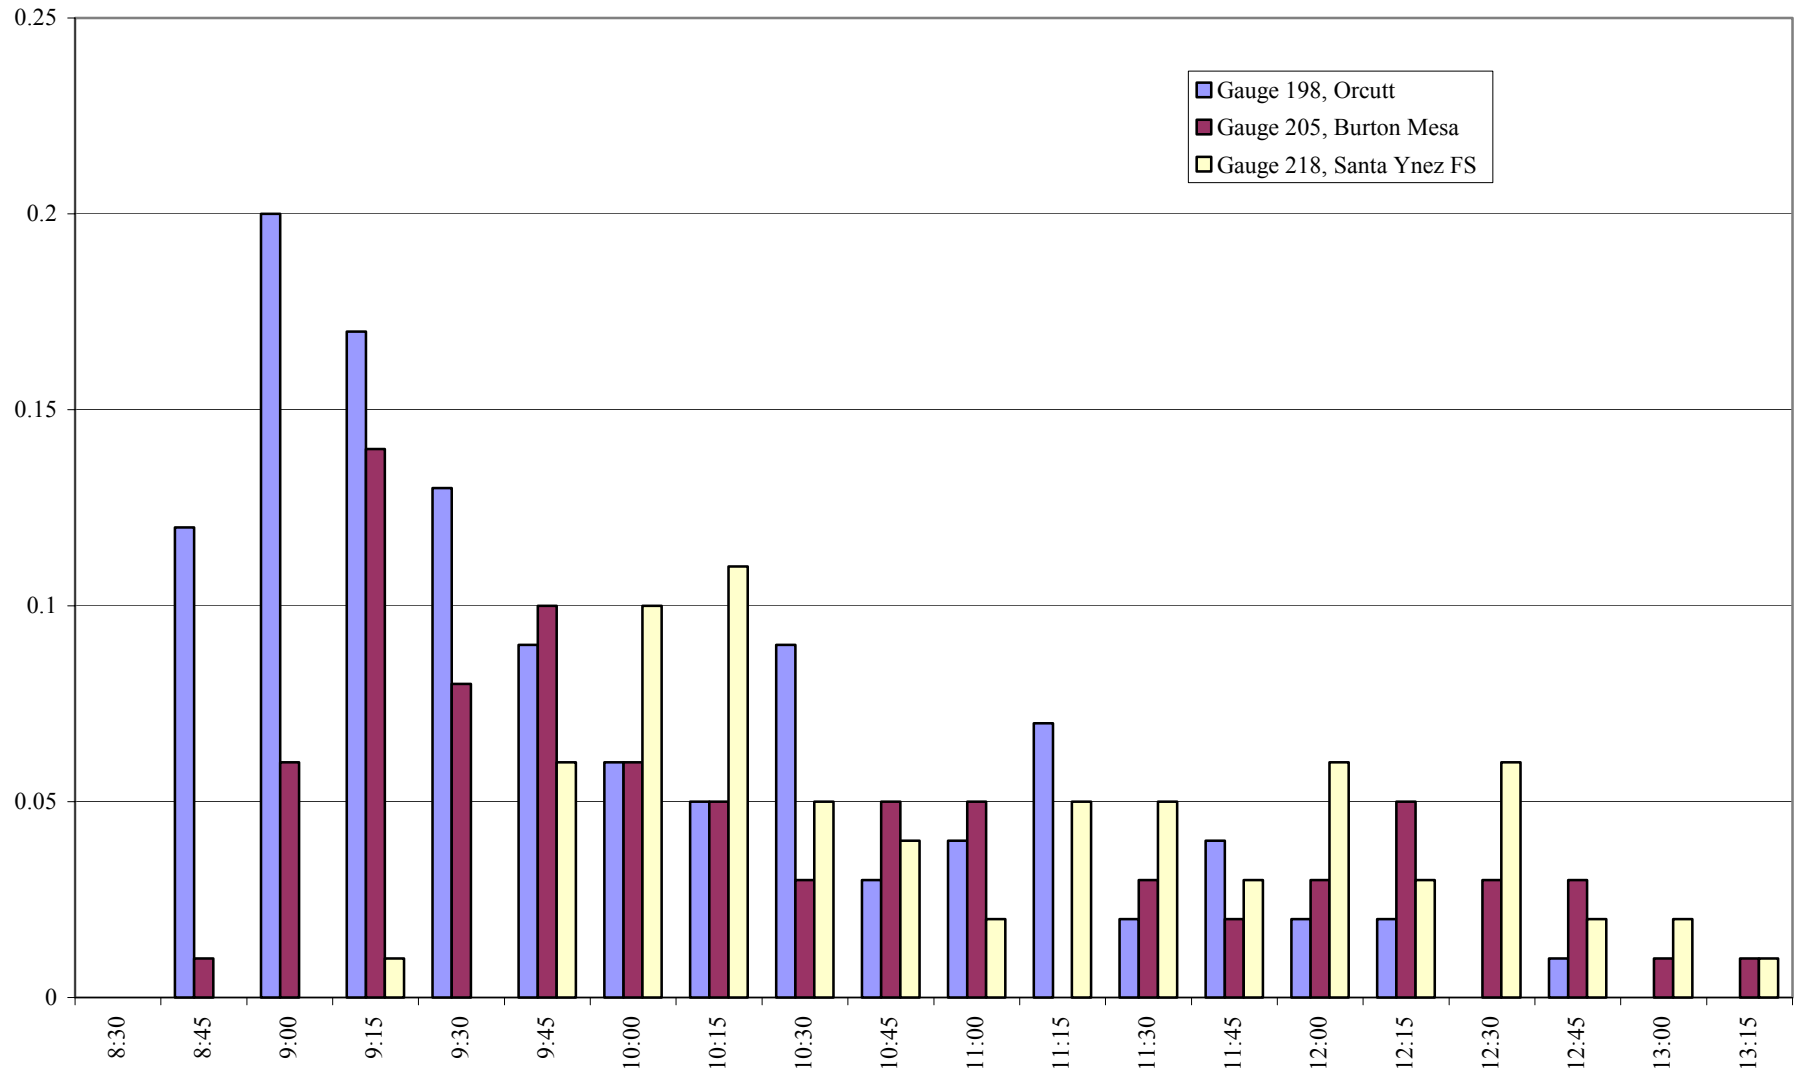
Figure B-3b. Rainfall for December 16, in inches (North County creeks sampled 0940-1210)

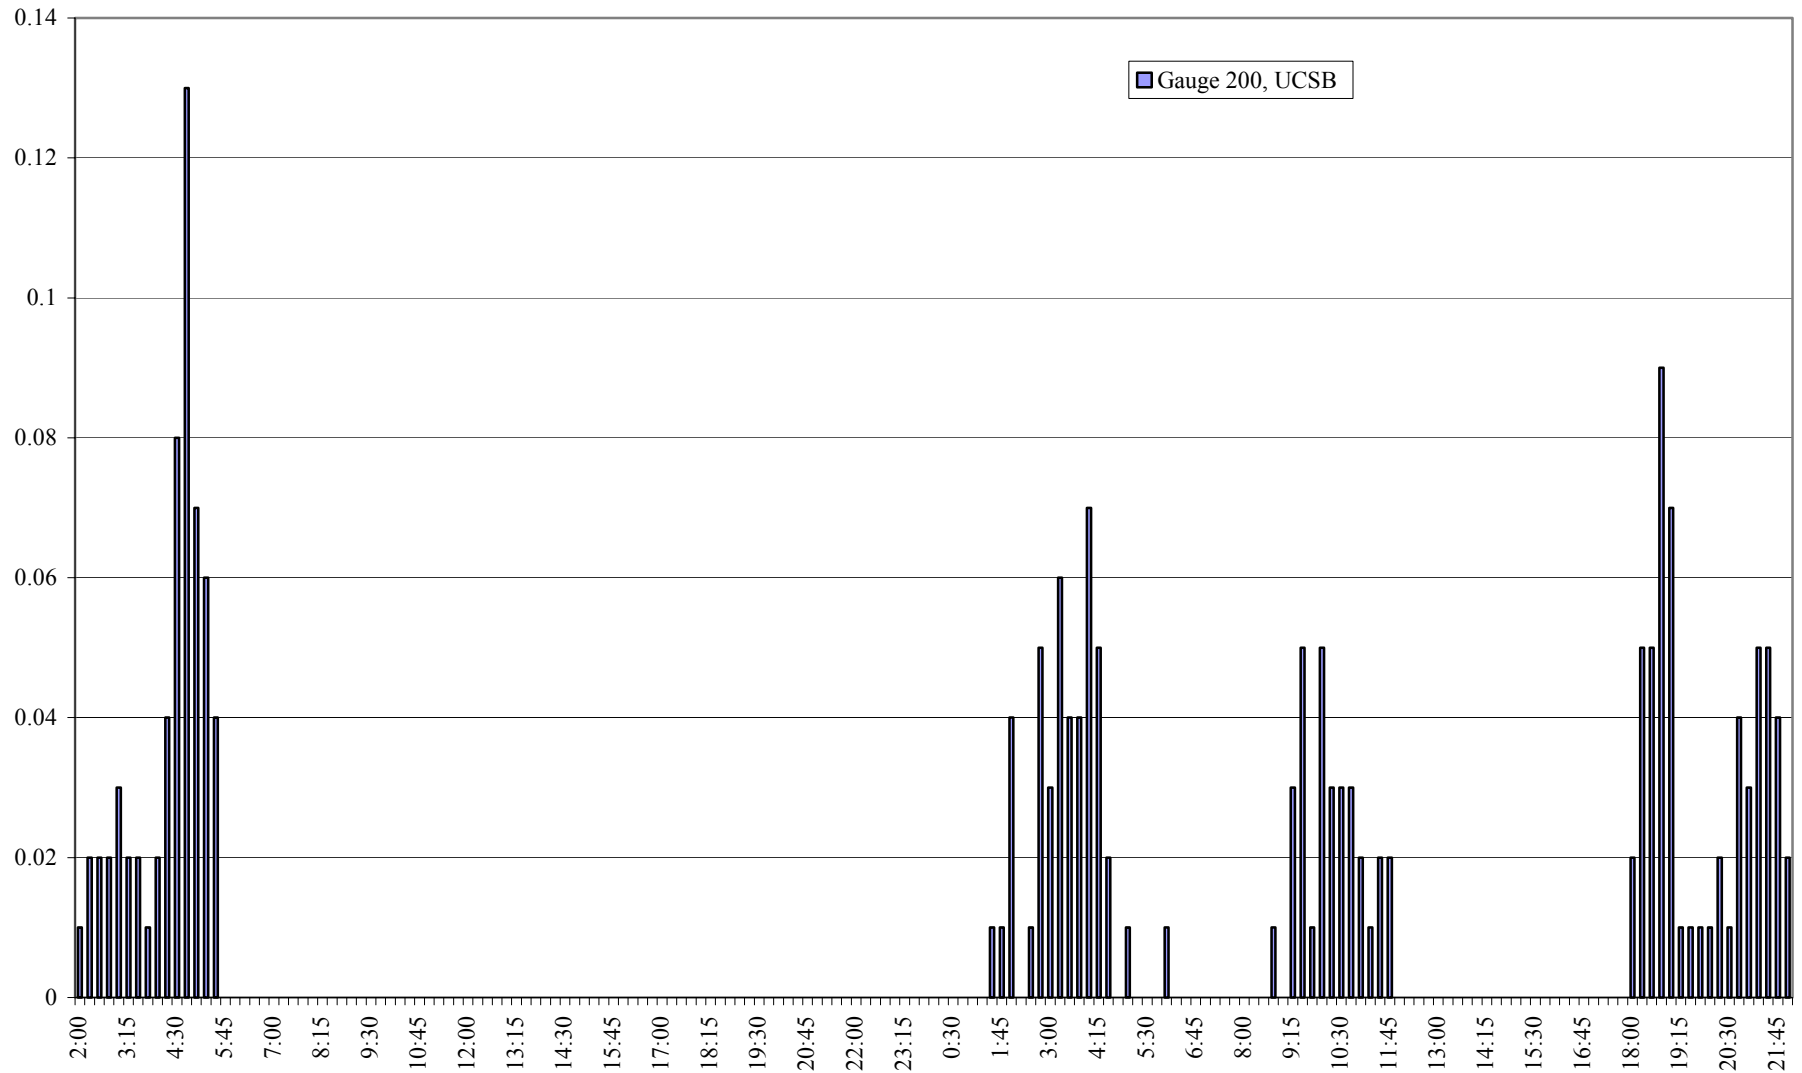
Figure B-4a. Rainfall for February 11-12, in inches (San Jose creek sampled 0515-1415)

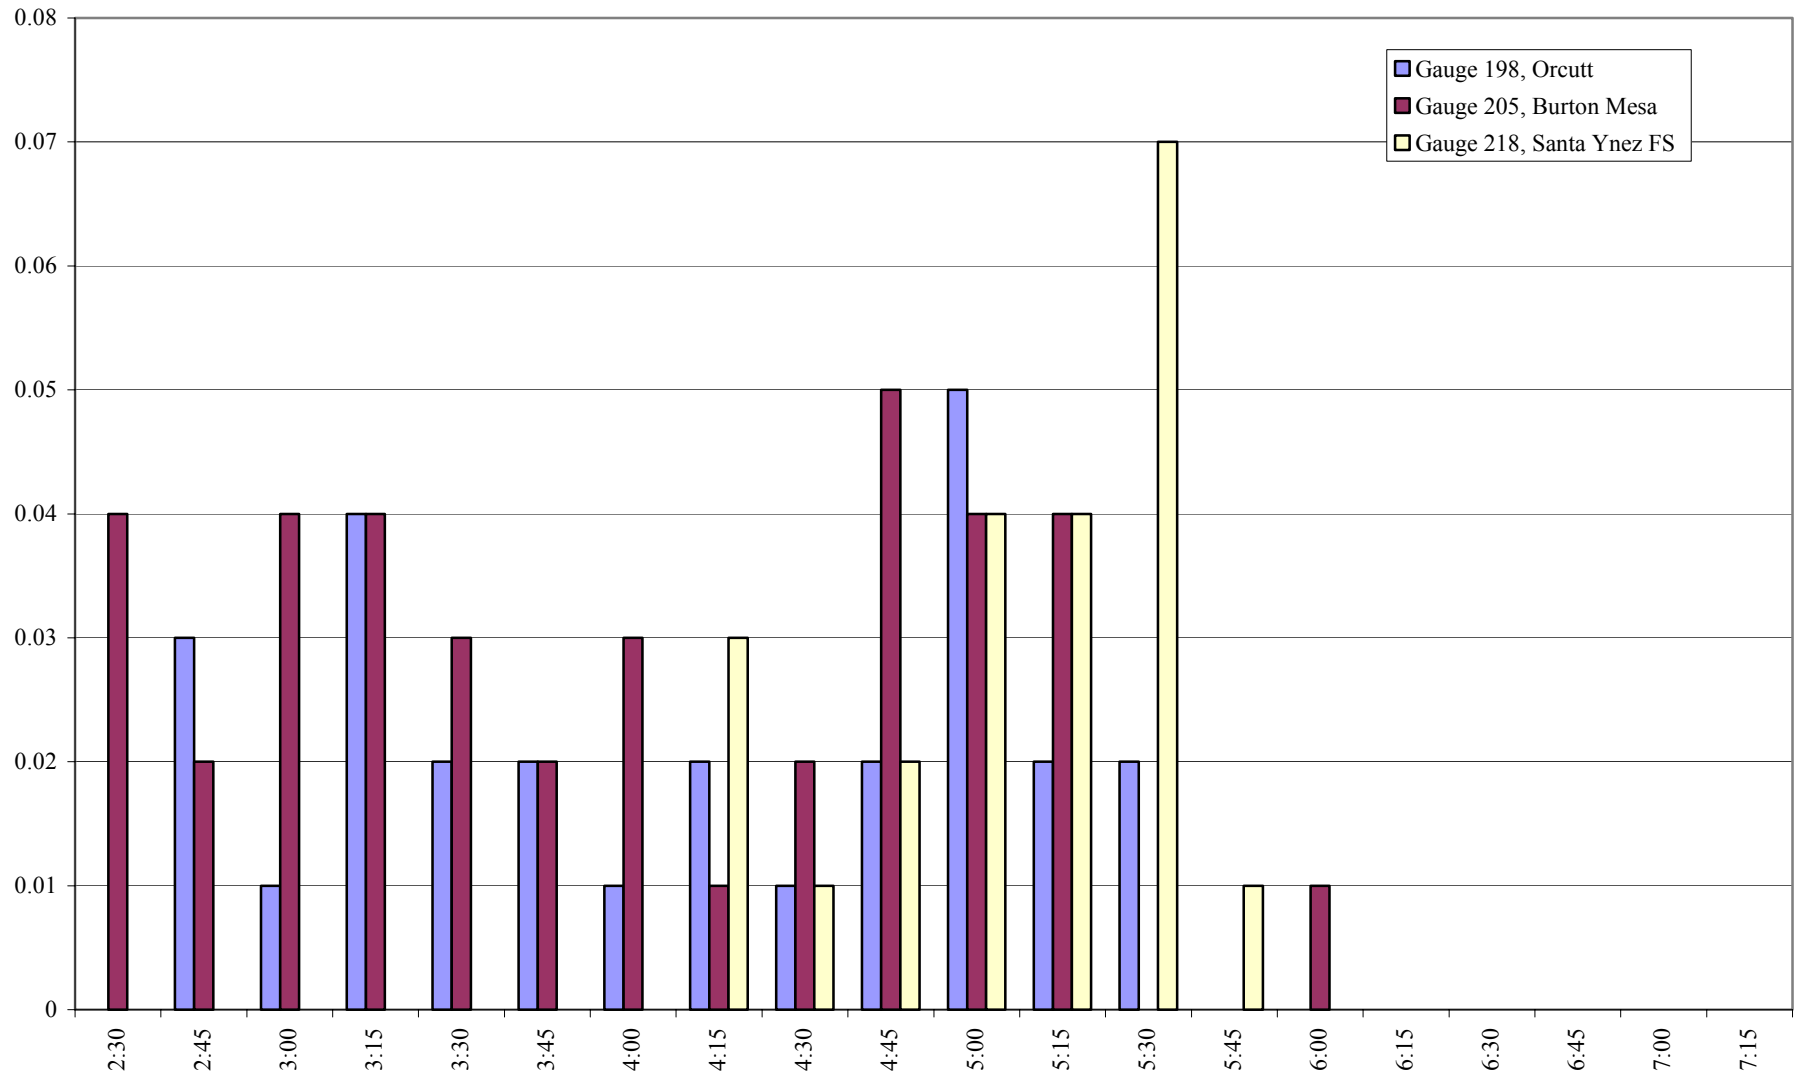
Figure B-4b. Rainfall for February 12, in inches (North County creeks sampled 0500-0700)

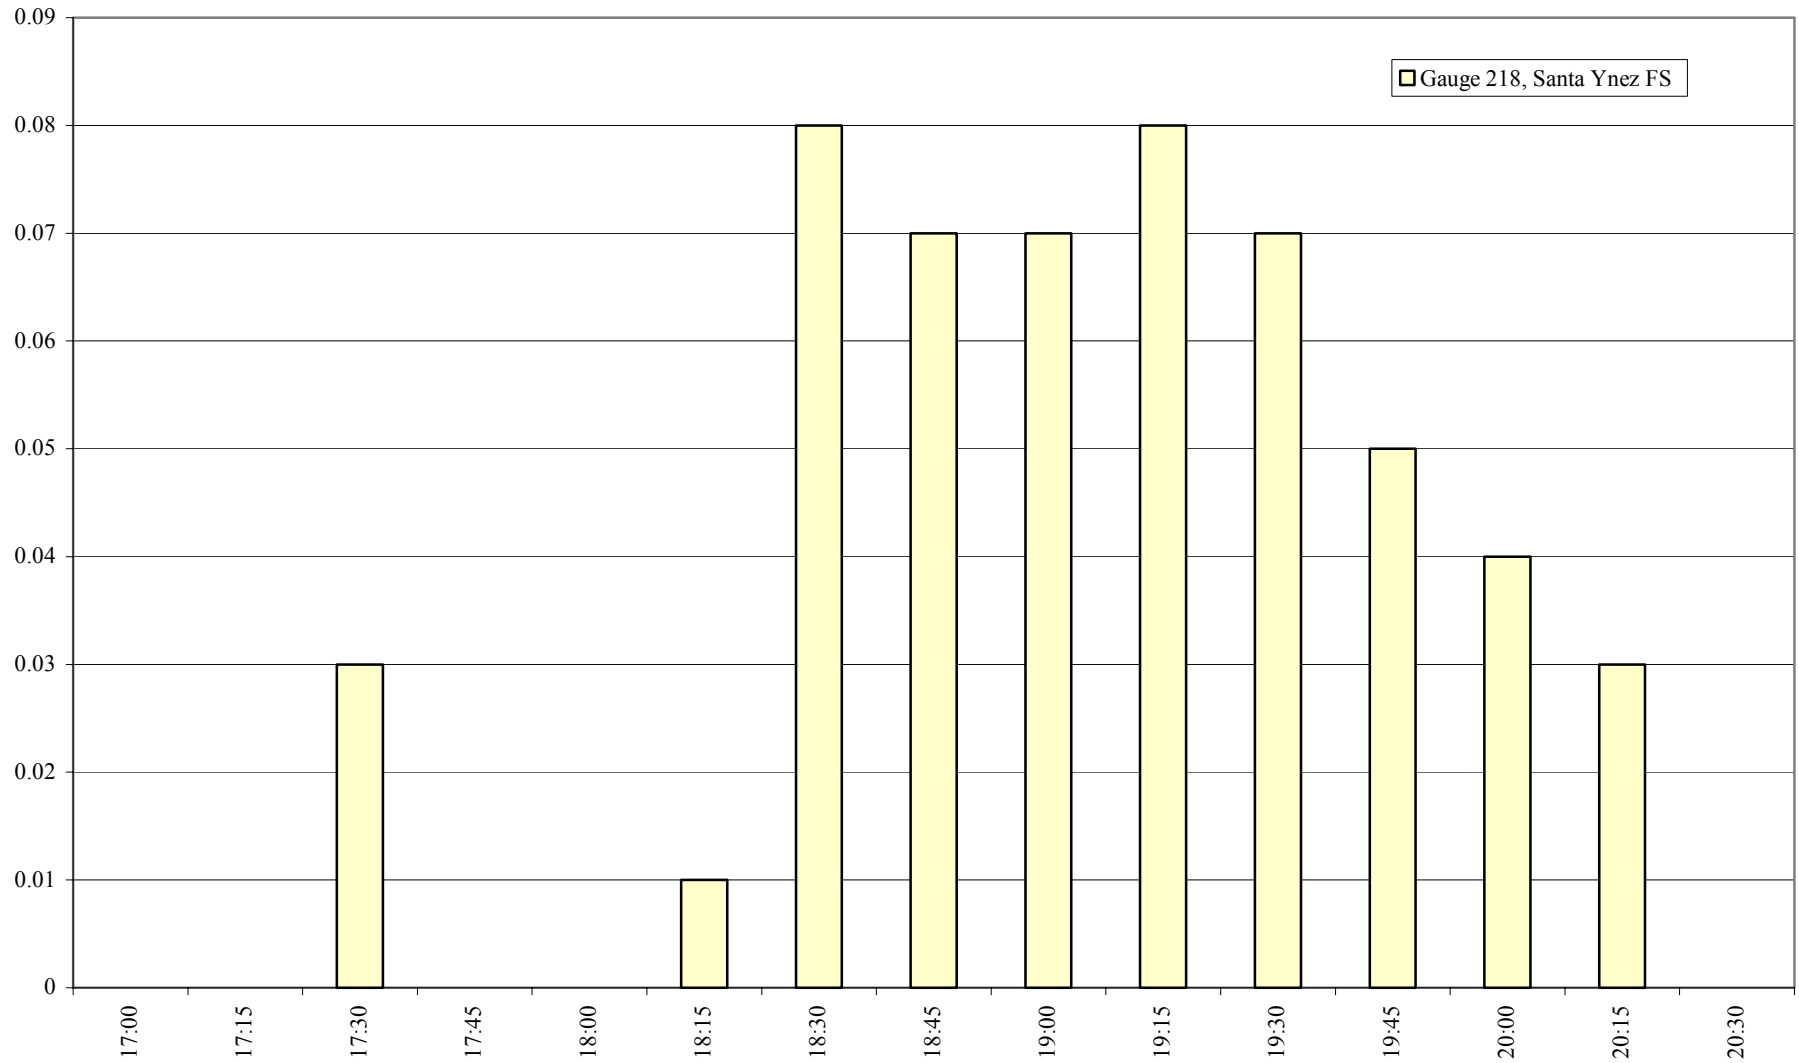
Figure B-5. Rainfall for February 24, in inches (Santa Ynez creeks sampled 1959-2020)

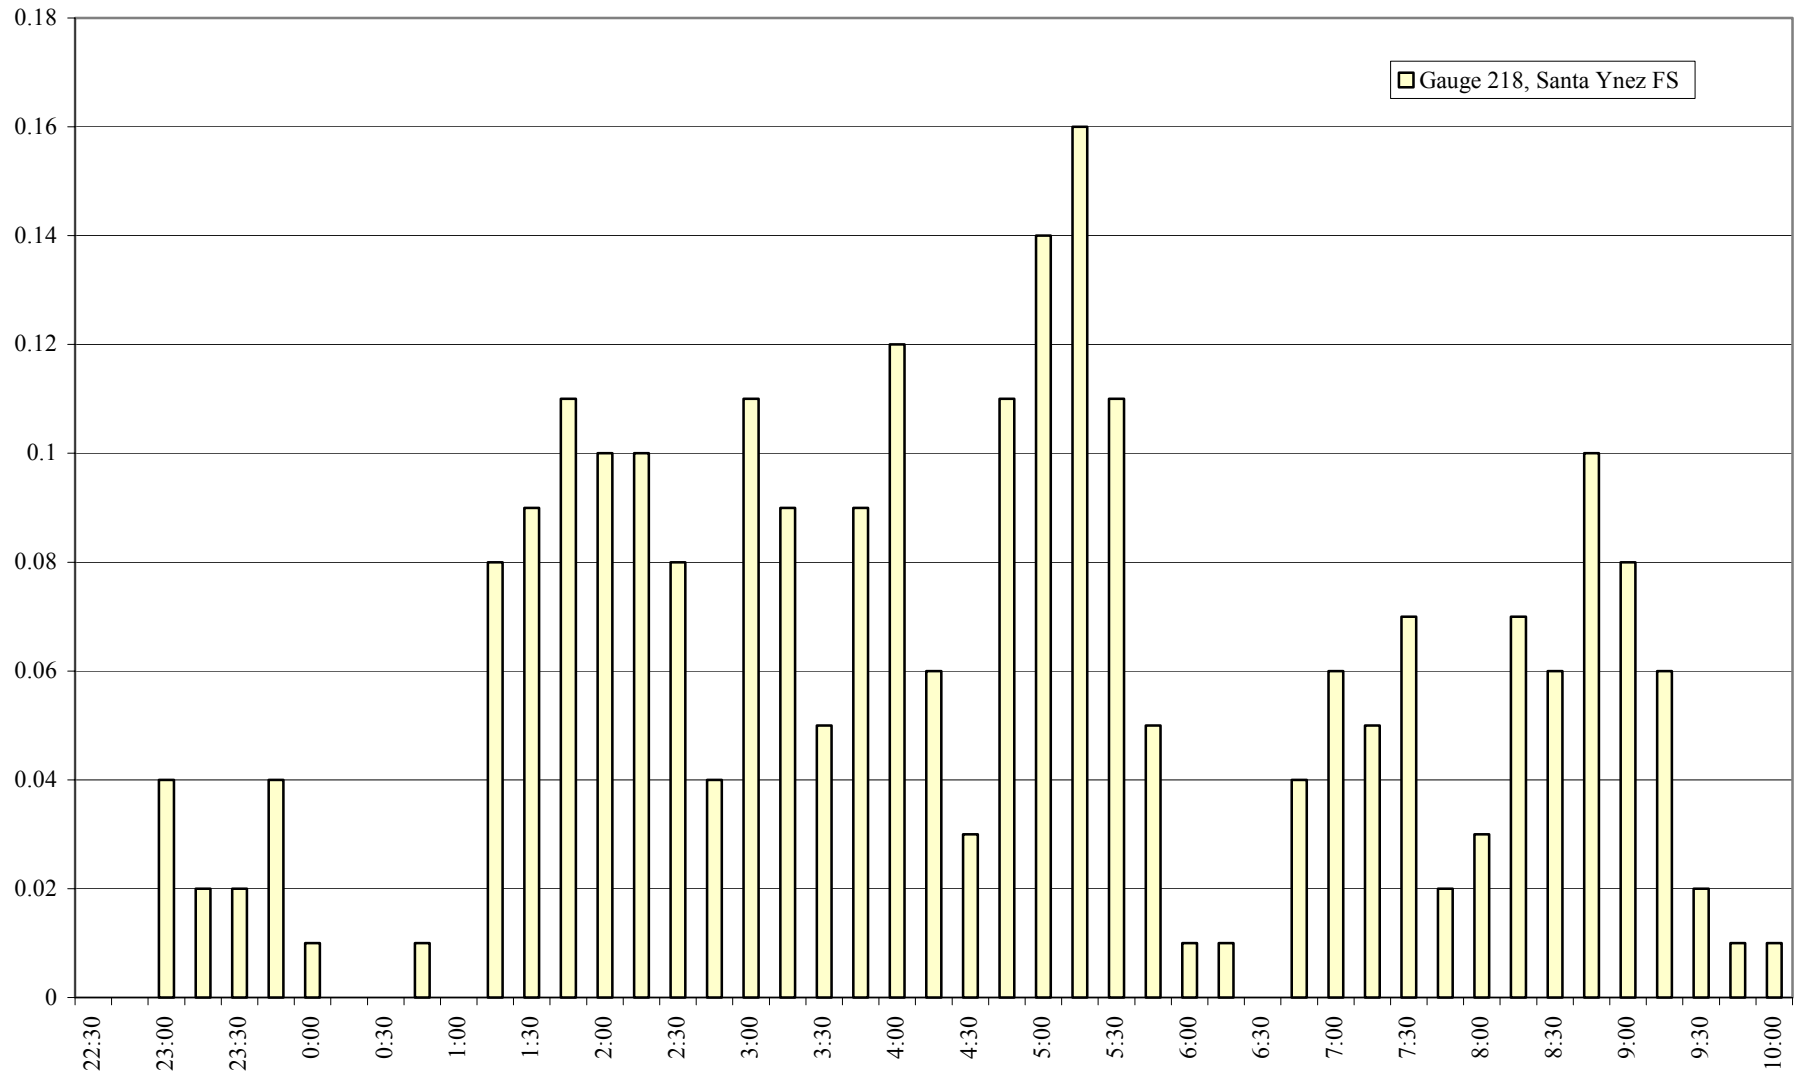
Figure B-6. Rainfall for March 15, in inches (Santa Ynez creeks sampled at 0440)
