Figure 6: Study Reach Photographs

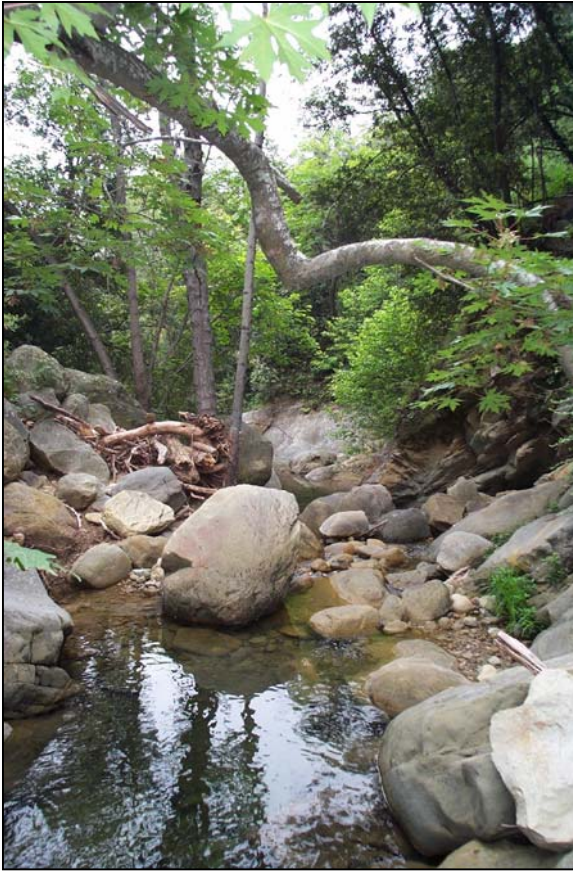
Photograph of San Jose Creek (Reach SJ-3)

These photographs were taken at San Jose Creek (top photo) and San Roque Creek (bottom photo). These relatively undisturbed creek sections have natural beds and banks and moderate gradients. The creek bottom consists of exposed bedrock and boulders, and deposits of cobble, gravel and sand. Fine sediments such as clay and silt are generally absent. Woody debris, leaf litter and tree roots are also present in the streams, providing cover and food for BMIs and aquatic vertebrate species. Riparian vegetation provides cover and shade, keeping water temperature low. Cold water holds higher concentrations of dissolved oxygen (i.e., compared to warm water), and is required by many aquatic wildlife species (e.g., steelhead/rainbow trout) that cannot tolerate low dissolved oxygen levels.
