**Figure 7: Study Reach Photographs**

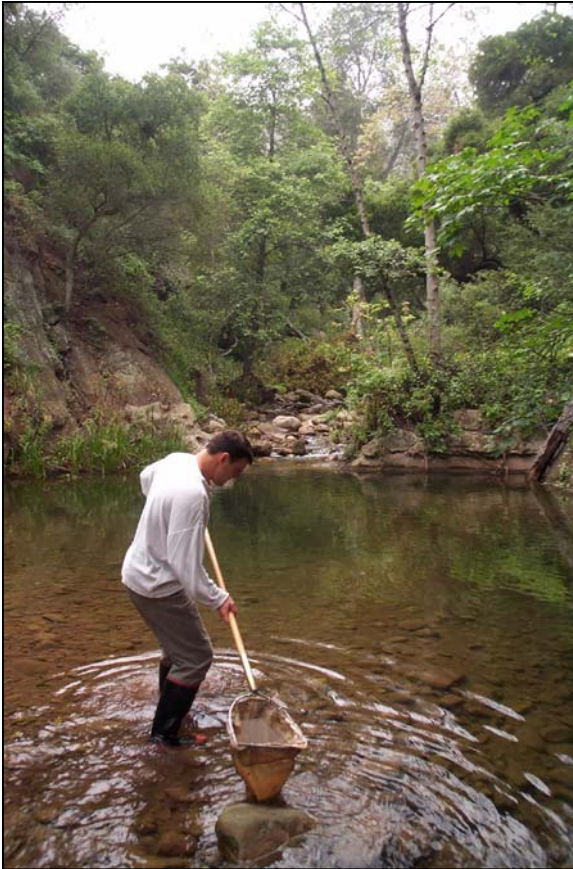
The above photographs were taken at Gobernador Creek (Reach C-3), a relatively undisturbed creek of moderate gradient. The photograph on the left shows a large pool. This pool is approximately 6 feet deep and has a diversity of bottom substrata (i.e., boulders, cobble, gravel sand and fine sediments, etc.). Notice also the clarity of the water, and the absence of algal growth. The photograph on the right shows a riffle section just downstream of the pool. The mostly native riparian vegetation and steep, bedrock banks at this creek reach are also visible in the photographs. Numerous steelhead/rainbow trout and California newts were observed in this study reach. The BMI community in this reach is particularly diverse, including numerous species that are typically found only in undisturbed streams with good water quality.
