# SOUTHERN COASTAL SANTA BARBARA CREEKS BIOASSESSMENT PROGRAM

## 2010 REPORT

City of Santa Barbara,  
Creeks Division

County of Santa Barbara,  
Project Clean Water

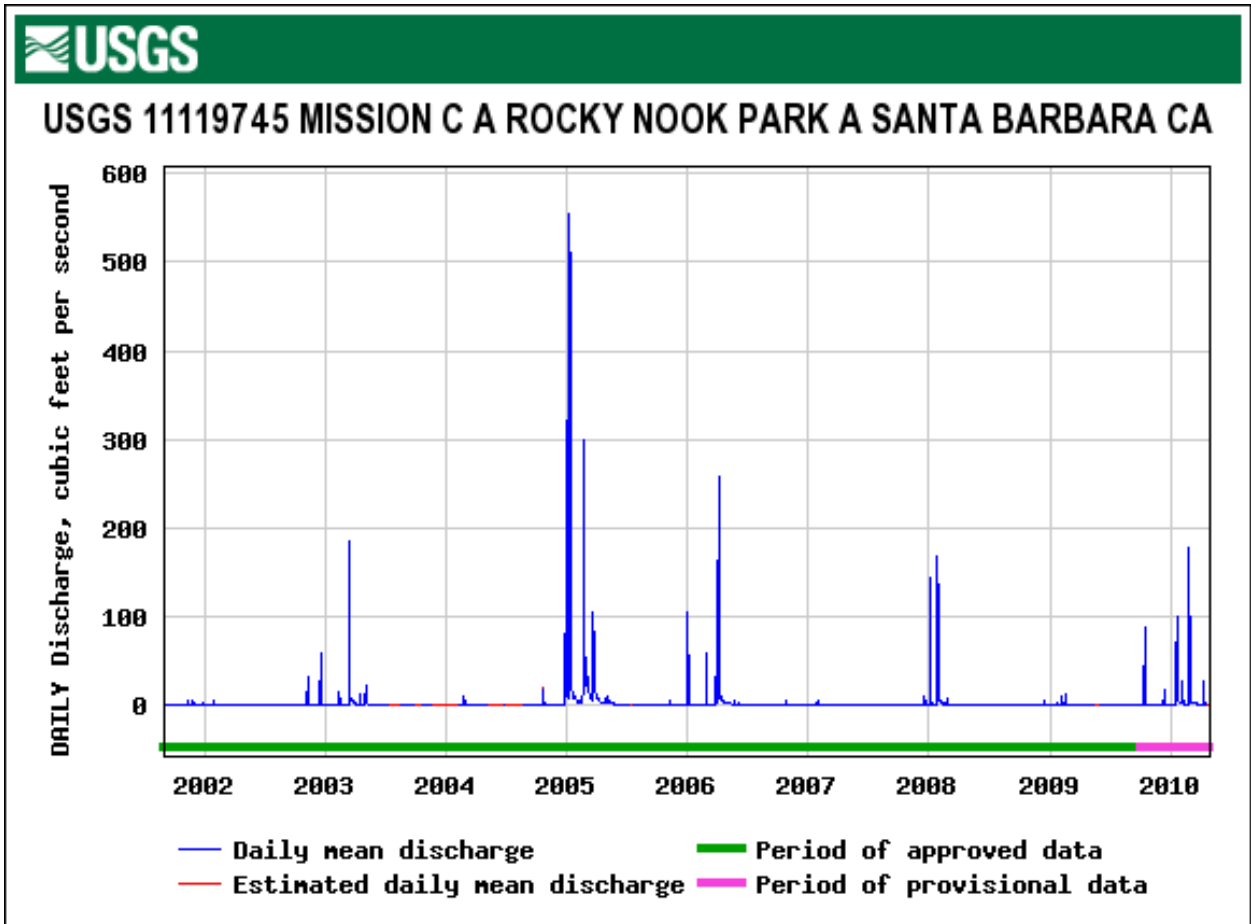
**Figure 5: Peak Daily Discharge, Mission Creek at Rocky Nook Park, 2002-2010**

Wet winters such as 2004-2005 with multiple high intensity rainfall events and high stream discharges scour out and transport large quantities of streambed material, and with it most of the invertebrate and vertebrate stream inhabitants. Large deposits of cobble, gravel, sand, and finer material accumulate in portions of the stream channels, particularly large pools, which can be completely filled in. Such events are a major disturbance to the stream community, the effects of which can last well into the spring when the bioassessment surveys are conducted. In 2005, BMI density was the lowest of any year of study, as were insect and EPT family diversity, percent EPT-Baetidae, percent PT, percent sensitive BMIs, and percent predators + shredders (See Table 5). Rapidly colonizing Baetidae mayflies made up over 50 percent of the BMI community in 2005, which is the highest percentage in any year of study. Clearly, the BMI community of the study streams had not recovered from the effects of scouring stream flows when the surveys were conducted in 2005.

For the most part, IBI score ranges and averages have been fairly consistent from year to year at the 12 study reaches. The exception to this was 2005, when the average IBI score was lowest (14), and the scoring range (1 to 29) was smallest by far. All 12 study reaches were in the Very Poor and Poor range, including AH1 and C3, which are in the REF category. 2005 was the second heaviest rainfall year on record since rainfall data was first collected locally in 1867.
